# 포항지진과 지열발전의 연관성에 관한 정부조사연구단 요약보고서

Summary Report of the Korean Government Commission on  
Relations between the 2017 Pohang Earthquake and EGS Project

March 20, 2019

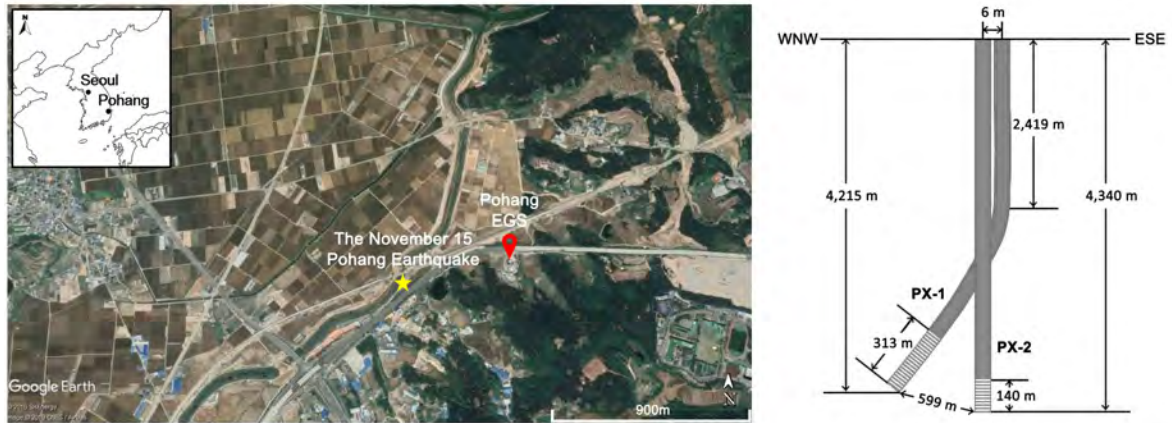
Figure O-1. Pohang EGS location and the schematics of the two exploration wells PX-1 and PX-2.

Over the course of approximately four years from 2012 to 2016, two exploratory wells named PX-1 and PX-2 were drilled into the bedrock to develop the enhanced geothermal system (Figure O-1). PX-1 had a designed depth of 4,127 m, but the drill pipe became stuck and was broken and not recoverable below a depth of 2,485 m. PX-1 was later side-tracked and extended in the WNW direction to a depth of 4,215 m, measured depth (MD) 4,362 m. PX-2 was drilled to a depth of 4,340 m (MD 4,348 m). Note that all depths were measured from the drill rig floor, which is 9 m above the ground surface.

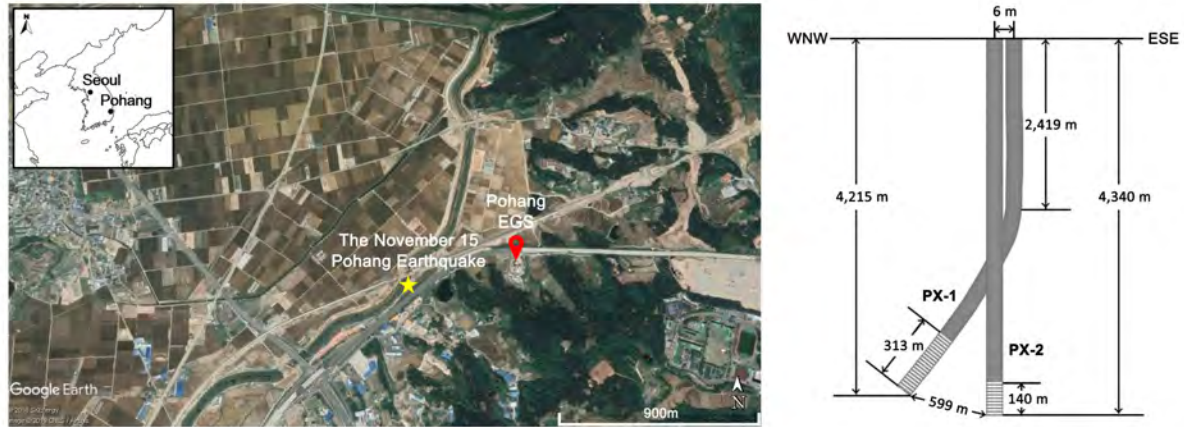
PX-1의 수직심도는 4,215 m이며, 물이 주입 또는 생산되는(즉 물의 유출입이 일어나는) 나공의 길이는 지열정 하단 313 m이며, 나머지 상부 구간은 케이싱으로 처리되었다. PX-2의 수직심도는 4,340 m이며, 나공의 길이는 140 m이다. 지표에서 PX-1과 PX-2 두 지열정의 거리는 약 6 m이며, 지열정 하단에서의 거리는 약 600 m이다.

Fig. 1-1. Location of Pohang EGS project site and the epicenter of the 15 November 2017 Pohang Earthquake (left) and schematic diagram of PX-1 and PX-2 geothermal wells (right).

포항 지열발전 실증연구 부지에서 2012년 9월부터 2013년 10월까지 시추를 진행하여 심도 4,127 m (Measured Depth, MD)인 최초의 지열정(PX-1)을 완성하였다. 시추 완료 이후 공벽 정리 과정에서 드릴파이프가 절단되어 하부 구간의 드릴 파이프가 시추공에 잠기게 되었다. 이에 PX-1 지열공에서 드릴파이프를 회수하고 지열공을 복원하기 위한 노력이 2015년 11월부터 전개되었고 2,485 m 심도까지 파이프 회수와 시추공을 복원할 수 있었다. 하지만 나머지 구간이 여의치 않아 PX-2 굴착이 완료된 이후, 기존의 PX-1의 심도 (MD) 2,419 m에서 경사시추를 통해 새로운 경로로 굴착하여 현재의 심도 4,362 m (MD)인 지열정 PX-1을 2016년 11월에 완성하게 되었다. PX-2 지열정은 2015년 4월부터 시추를 시작하여 2015년 12월에 심도 4,348 m (MD)의 깊이로 설치를 완료하였다. 완성된 PX-1과 PX-2 지열정의 구조는 Fig. 1-1과 같다.

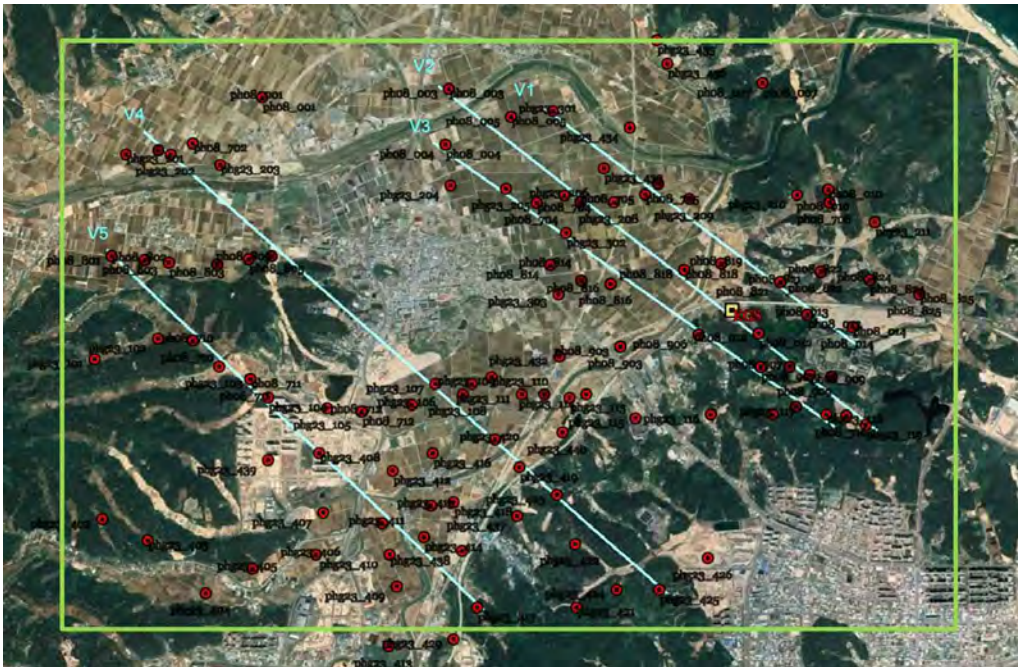
Fig. 3-1. MT/AMT site map. The solid lines and the green box represent the survey lines for 2D interpretation and 3D inversion area, respectively.

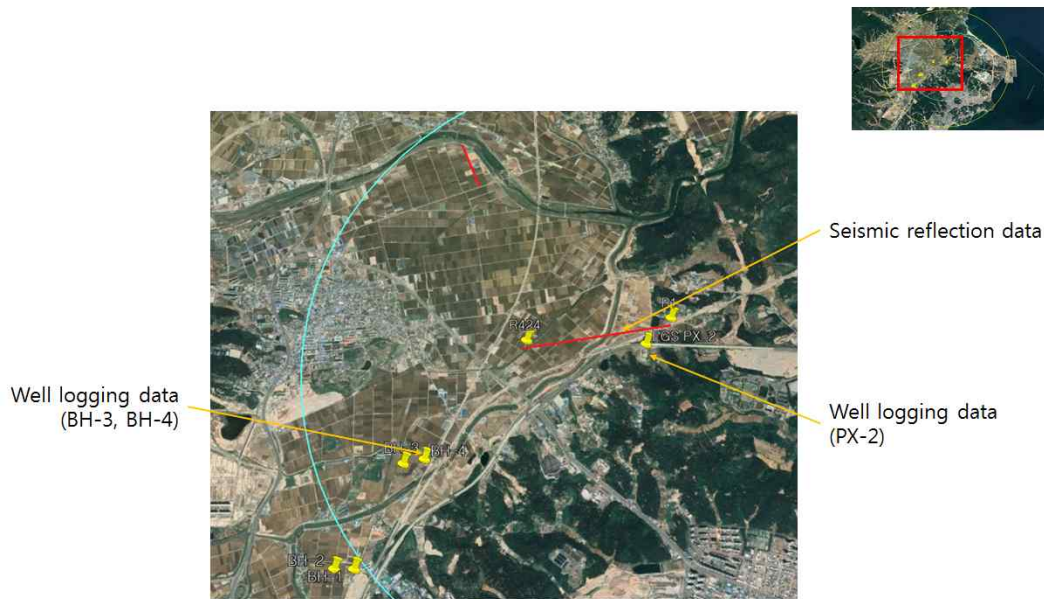
Fig. 3-5. Locations of the EGS site, boreholes, seismic reflection survey line.

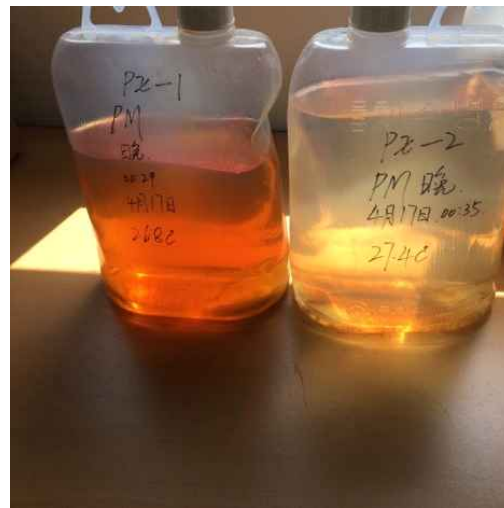
수리자극 기간에 발생한 가장 큰 규모의 지진은  $M_w$  3.2의 지진이다. 이 지진은 PX-2에서 실시된 3번째 수리자극의 종료 시점인 shut-in 기간에 발생하였다. 지진 직후 PX-1과 PX-2 두 지열정으로부터 물을 배출하였으며, PX-1과 PX-2에서 배출되는 물의 색깔이 확연히 차이가 났다(Fig. 6-9).

Fig. 6-9. Flow back water from PX-1 (left) and PX-2 (right) after  $M_w$  3.2 earthquake.

PX-1과 PX-2 지열정에서 배출되는 물의 수질과 안정동위원소의 양상이 크게 다르게 나타났다(Fig. 6-10). PX-2의 경우 주입수로 사용되었던 주변 저수지의 물과 거의 비슷한 산소수소 동위원소 성분을 보여주는 반면, PX-1에서 배출된 물의 산소수소 동위원소는 지열수의 특징을 보여주고 있다(Fig. 6-10). 지열수의 산소수소 동위원소는 지하 심부의 고온, 고압 하에서 물 암석 반응의 증가로 인해 강우 기원의 물과 다른 양상을 보여준다(Stefansson et al., 2017; Piña et al., 2018). PX-2에서 배출된 물의 산소수소 동위원소 값은 지역 순환수선(LMWL)에 좀 더 가까운 값을 보인다. 이는 PX-2 수리자극에 사용한 강우 기원의 저수지 물과 지열수와 혼합되기 때문이다.
